Manhole Inspection Summary

Manhole # S51K__019MH

Insp Date: **4/1/08 8:53 AM**

Location Address: **802 s. potomac st**

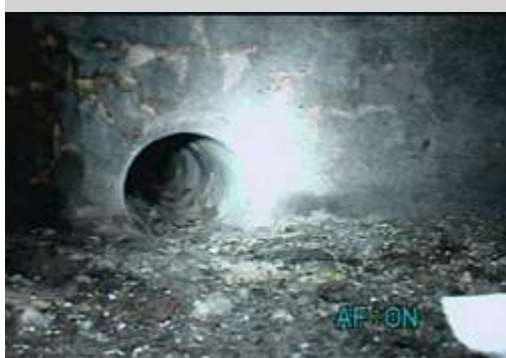
misc. channel debris

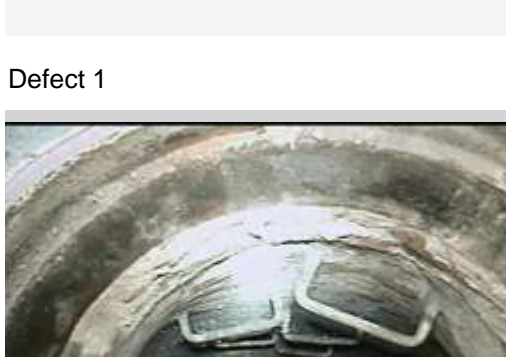
Defect 1

Infiltration: ☐ None ☒ **Joint** ☐ Cracks ☐ Mortar ☐ Roots ☐ Wall

infiltration at chimney joint

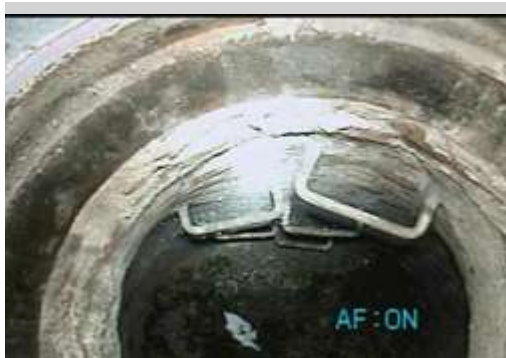
Count: **5** Missing: **0** ☒ **Corroded**

steps

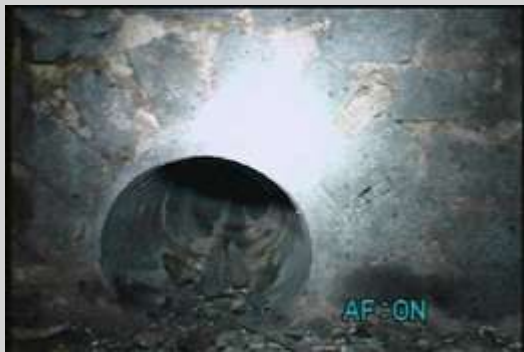
12 O'Clock Outflow

8 in. Circular Gravity Sewer
Pipe Out @ 12 O'Clock
